**DEPARTMENT OF TRANSPORTATION**

Contract #: 04-0120F4Cty: SF/ALA Rte: 80 PM: 13.2/13.9File #: 69.28**WELDING INSPECTION REPORT****Resident Engineer:** Siegenthaler, Peter**Address:** 333 Burma Road**City:** Oakland, CA 94607**Report No:** WIR-020996**Date Inspected:** 25-Feb-2011**Project Name:** SAS Superstructure**OSM Arrival Time:** 700**Prime Contractor:** American Bridge/Fluor Enterprises, a JV**OSM Departure Time:** 1900**Contractor:** Zhenhua Port Machinery Company, Ltd (ZPMC), Changxing Island **Location:** Shanghai, China**CWI Name:** Qiu Wen, An Qing Xiang**CWI Present:** Yes No**Inspected CWI report:** Yes No N/A**Rod Oven in Use:** Yes No N/A**Electrode to specification:** Yes No N/A**Weld Procedures Followed:** Yes No N/A**Qualified Welders:** Yes No N/A**Verified Joint Fit-up:** Yes No N/A**Approved Drawings:** Yes No N/A**Approved WPS:** Yes No N/A**Delayed / Cancelled:** Yes No N/A**Bridge No:** 34-0006**Component:** OBG**Summary of Items Observed:**

## WELDING INSPECTION REPORT

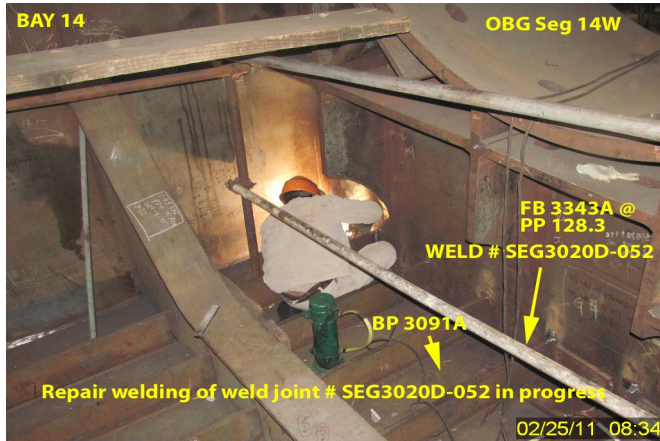
Repair welding of weld joint no: SEG3020D-052 [Bottom Plate (BP) 3091A to Floor Beam (FB) 3343A, Complete Joint Penetration (CJP) weld at panel point (PP) 128.3]. The welder is identified as 045246 and was observed welding in the 2G position. Welding process was identified as Shielded Metal Arc Welding (SMAW). AB/F QA was identified as Mr. Xiao Jun Peng. The welding variables recorded by this QA appeared to comply with WPS: 345-SMAW-2G(2F)-FCM-Repair-1. Repair welding was done as per Critical Welding Repair (CWR) Report: B-CWR 2734 Rev-2. Attached photograph provide additional details.
